South Park Bridge

Rehabilitation Feasibility Study

Technical Memorandum

prepared for:
King County Department of Transportation

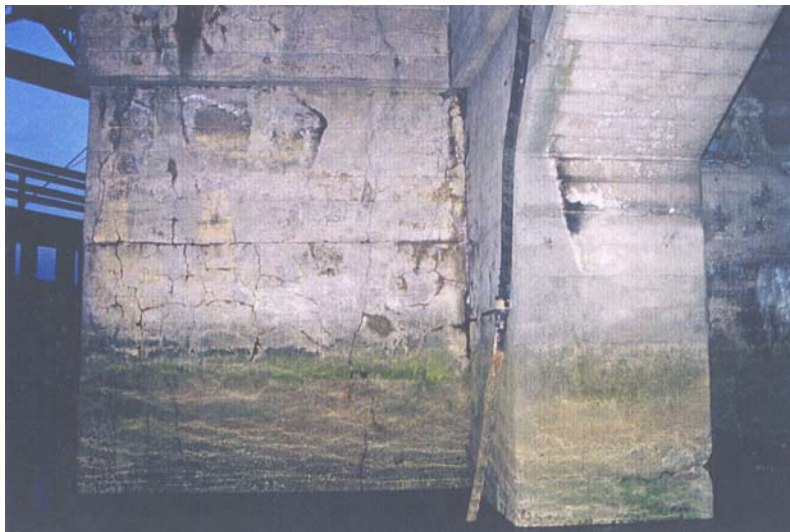
Photo 2: North Bascule Pier (East Face)

In 2000, the rating from the *WSBIS Bridge Inspection Report* [Ref. 19] for the substructure was 4 out of 8 (8 indicates excellent condition) [Ref. 27]. A 4 rating corresponds to poor condition. In 2002, the rating for the substructure moved down to a 3 rating, which is considered in "serious condition" per NBIS, which corresponds to the following statement [Ref. 27]: "Loss of section, deterioration, spalling or scour have seriously affected primary structural components. Local failures are possible." See Photos 2 through 5, 7, and 8.

Note the numerous hairline cracks that extend across the face of the bridge in the splash zone.
(from *Echelon Engineering Inspection Report*, Ref. 18)

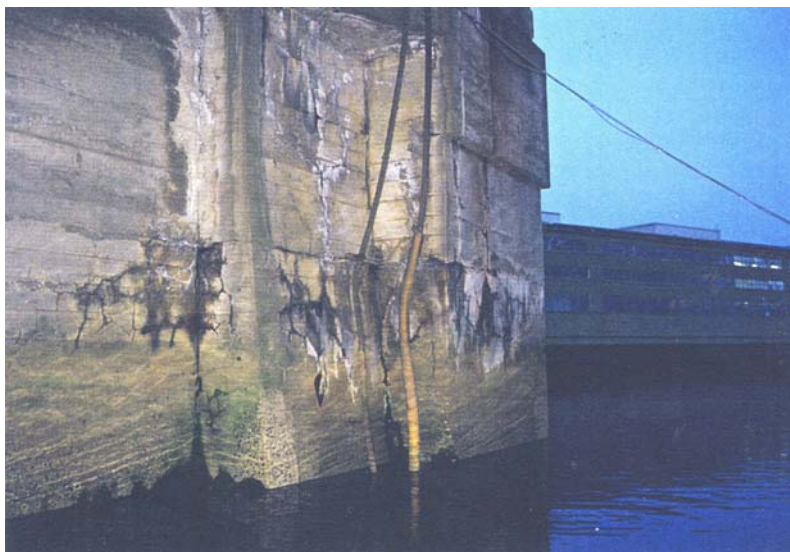
Photo 3: North Bascule Pier (South Face)

Note the extensive hairline cracking (map cracking) with efflorescence.
(from *Echelon Engineering Inspection Report*, Ref. 18)

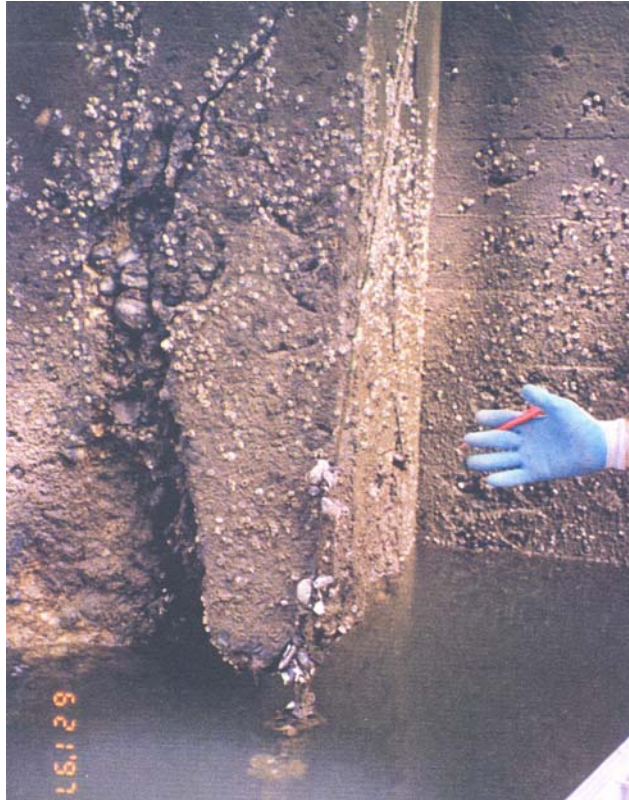
Photo 4: North Bascule Pier (South Face Detail)

Note the large corner spall that exhibits an extensive loss of concrete immediately below the water.
(from *Echelon Engineering Inspection Report*, Ref. 18)

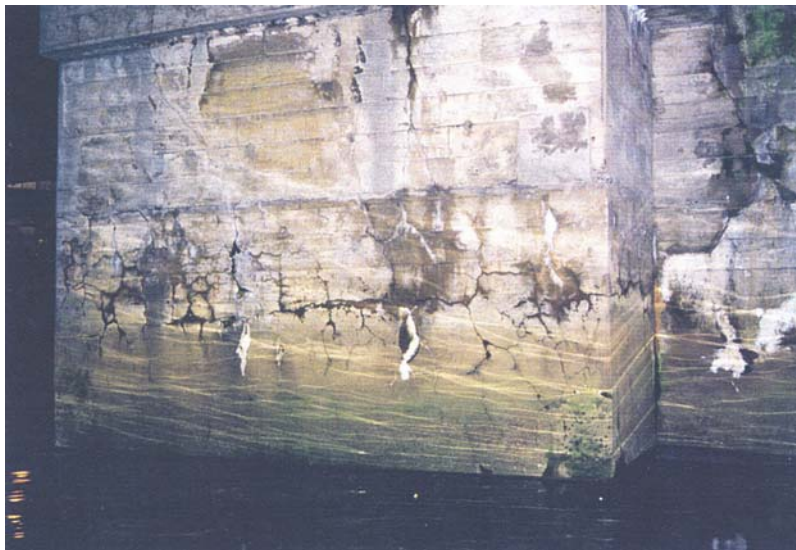
Photo 5: North Bascule Pier (West Face)

Note the extensive hairline cracking (map cracking) and efflorescence.
(from *Echelon Engineering Inspection Report*, Ref. 18)

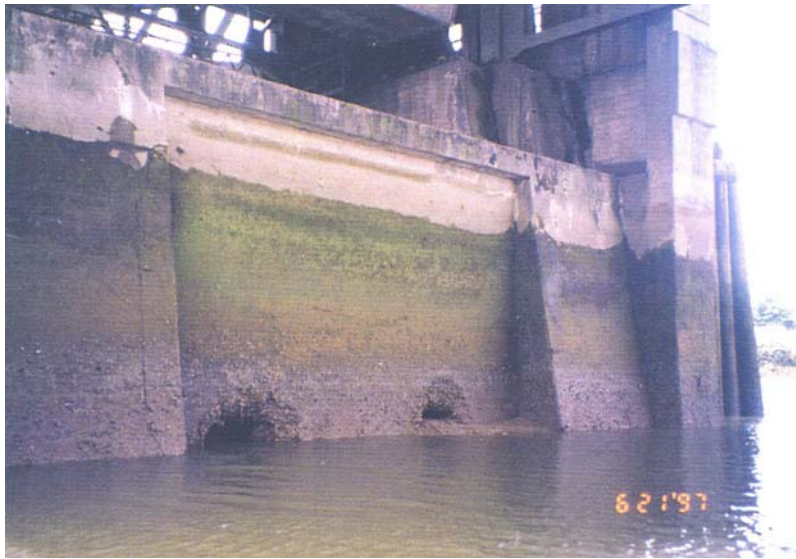
Photo 6: North Bascule Pier (North Face)

Spalling of the inlet/outlet locations. Note the exposed rebar at the left opening and the sedimentation of the right opening.
(from *Echelon Engineering Inspection Report*, Ref. 18)

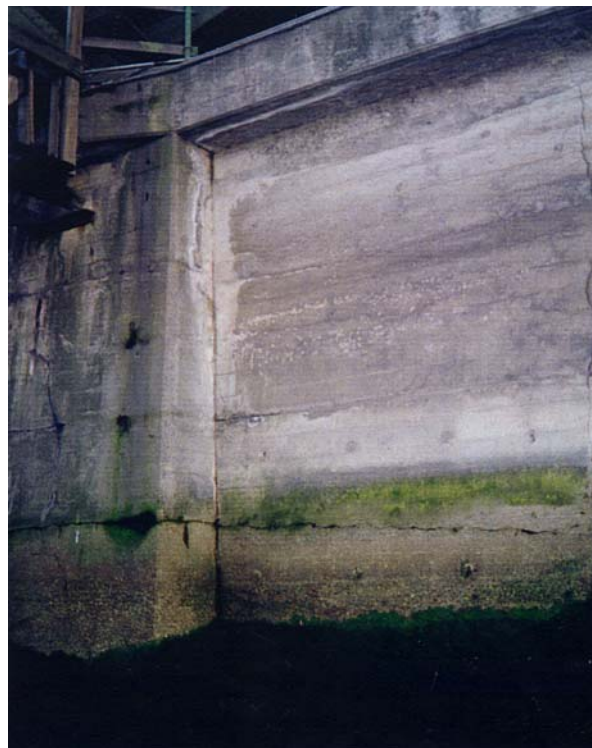
Photo 7: South Bascule Pier (North Face)

Note the vertical crack at far right.
(from *Echelon Engineering Inspection Report*, Ref. 18)

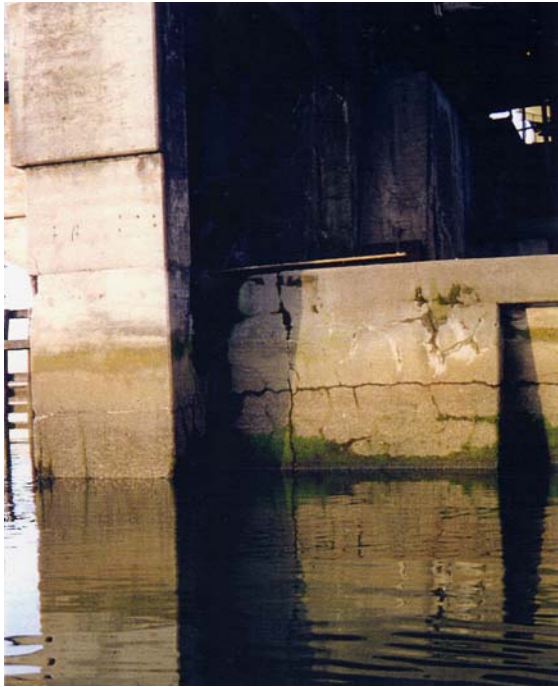
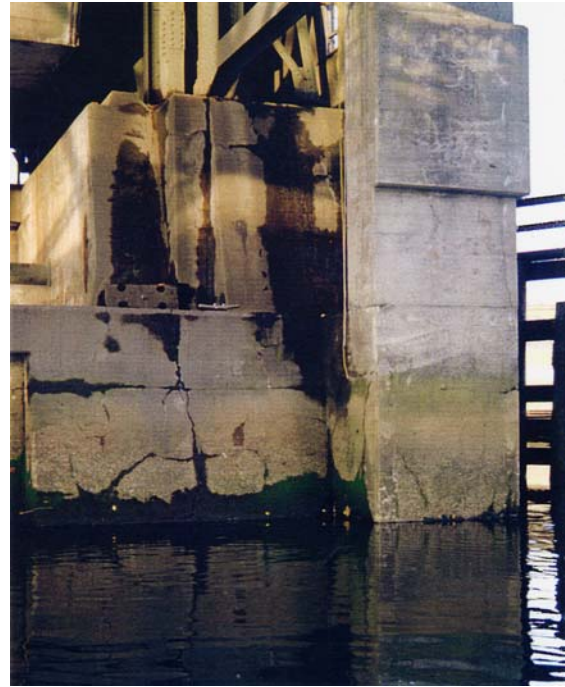
Photo 8: South Bascule Pier (South Face Details)

Note the corner spall, vertical and horizontal cracks along the face.
(from *Echelon Engineering Inspection Report*, Ref. 18)

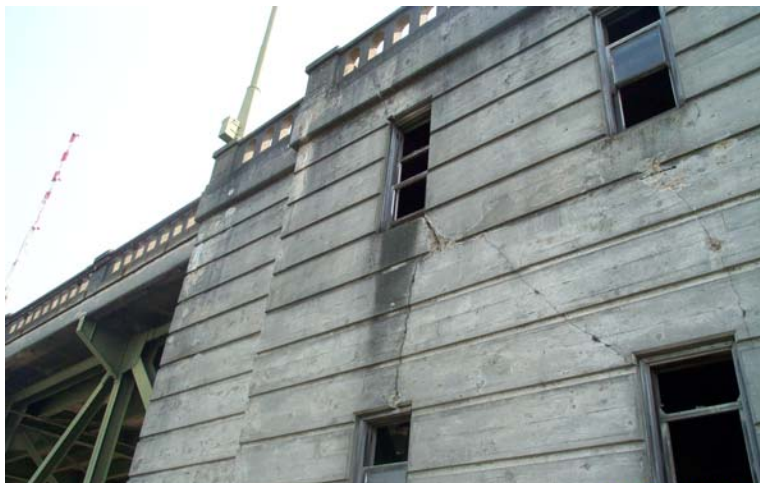
Photo 9: North Bascule Pier (West Wall)

The overall condition of the submerged section of the two bascule piers ranges from fair to poor. Evidence of significant deterioration in the form of cracking, spalling, and efflorescence is found in both piers. The north bascule pier has sustained the most significant deterioration of all six substructure piers, which support the bridge across the waterway [Ref. 8]. The counterweight pits on both bascule piers have an inflow-outflow opening to allow high tide waters to flow into and out of the pier. This wet-dry cycle of tides further aggravates any spalling due to rebar corrosion and chloride attack of the pier walls. See Photo 6. Cracking in the bascule piers is further exacerbated by the rolling action of the leaves and changes in load pressure on the foundation [Ref. 18]. See Photo 9.

Note the multiple and substantial cracks in the bascule pier wall.

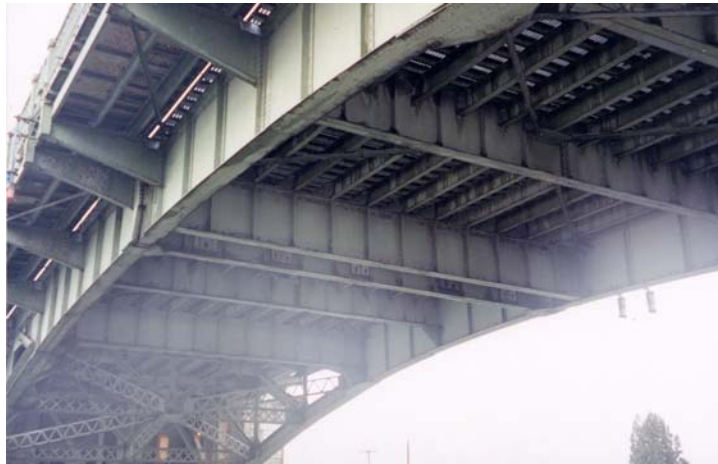
Photo 10: Bascule Leaves

"Fair condition" (a rating of 5) was assessed for the superstructure and deck in the *WSBIS Bridge Inspection Report* [Ref. 19]. The WSBIS/NBIS system defines fair condition as "all primary structural elements are sound but may have minor section loss, cracking, spalling, or scour" [Refs. 27, 42]. However, this rating does not preclude the possibility that the condition of individual structural members may be deteriorated and require subsequent replacement. See Photo 10.

Condition is fair, some corrosion discovered during bridge inspection [Ref. 19].

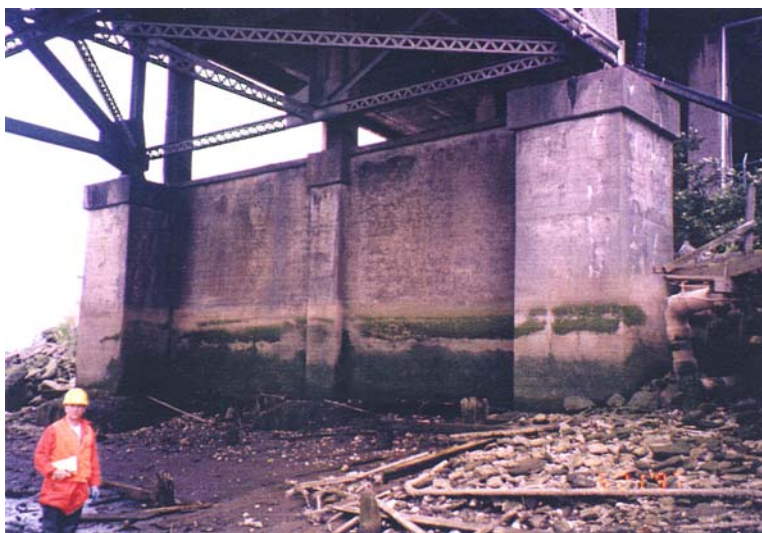
Photo 11: Steel Truss Approach, North Pier 2

The *Geotechnical Report* prepared by Shannon and Wilson in September 1991 indicated that subsurface soils above elevation -30 (City of Seattle datum) along both bridge approaches have a high potential to liquefy when subjected to the design ground motion (peak ground acceleration of 0.3g) [Ref. 2]. Piles for the steel approach truss foundations were driven to elevations ranging from -52 to -67 at Pier 1 for the north and south approaches, and elevations ranging from -33 to -41 at Pier 2 for the north and south approaches [Ref. 50]. The *Geotechnical Report for Conceptual Engineering – South Park Bridge Project* prepared by Shannon and Wilson in May 2003 [Ref. 28] indicated an increased soil liquefaction risk. For 475-year return-period ground motions and based on the available subsurface data, the estimated potentially liquefiable deposits would extend to approximately 35 feet (elevation -15) deep within and south of the Duwamish River Waterway. North of the waterway, these deposits would be extended to approximately 50 feet (elevation -35) deep. Liquefiable soils in the Duwamish River Valley may be subject to lateral displacement (lateral spreading) varying up to about 8 to 10 feet. Vertical settlement for these areas may also be as much as 2 feet [Ref. 46]. See Photo 11.

Note the spalling of the two exposed footings.

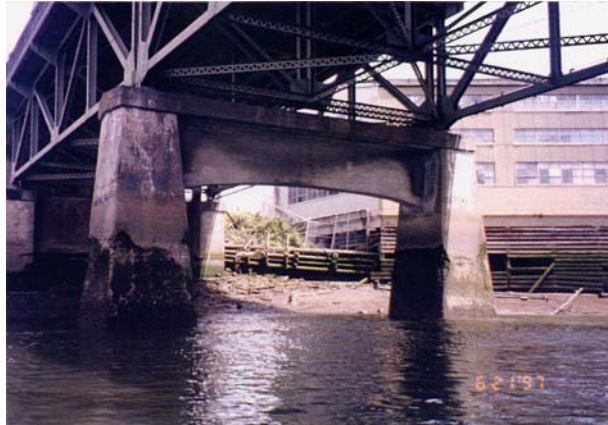
Photo 12: Steel Truss Approach, North Pier 1

Note the spalls and concrete repair patches on the corners of the columns.
(from *Echelon Engineering Inspection Report*, Ref. 18)

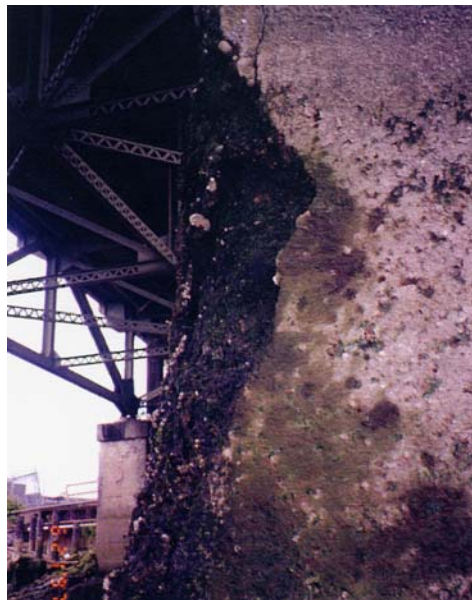
Photo 13: Steel Truss Approach, North Pier 1 East Column

Note the large spall on the southwest corner of
the column within the upper intertidal zone.
(from *Echelon Engineering Inspection Report*, Ref. 18)

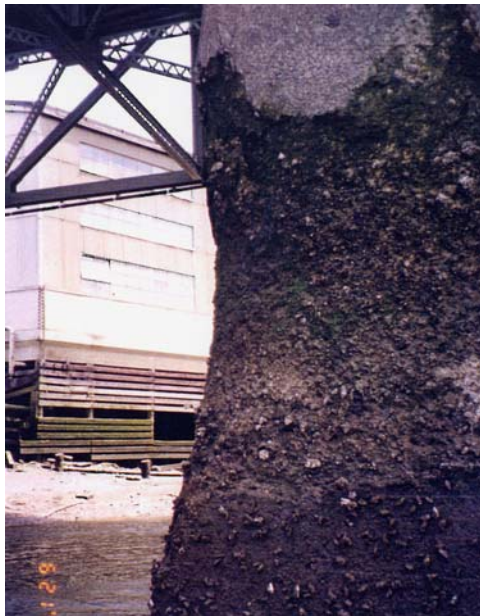
Photo 14: Steel Truss Approach, North Pier 1 West Column
Note the large spall on the northwest corner of the column.
(from *Echelon Engineering Inspection Report*, Ref. 18)

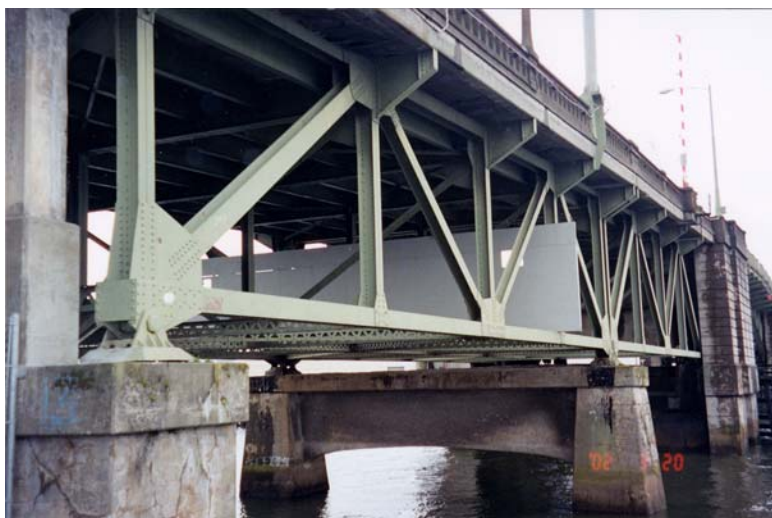
Photo 15: Steel Approach Trusses
Note condition appears to be fair.
(from *Echelon Engineering Inspection Report*, Ref. 18)

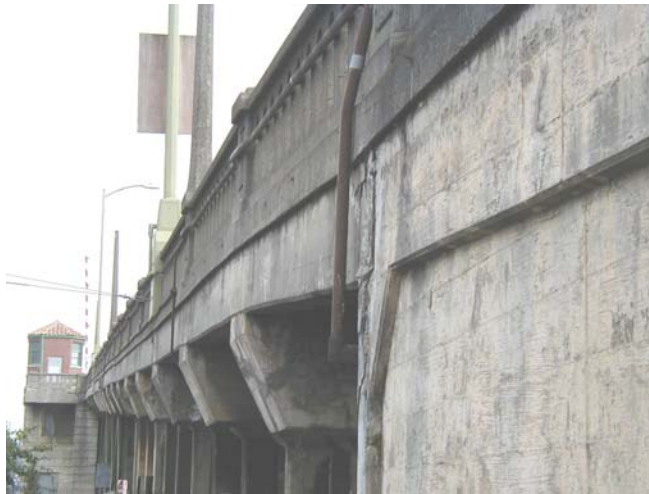
Photo 16: South Abutment Settlement

In addition to the liquefaction risk described previously in the *Steel Approach Truss Foundations* section, the south earth-filled abutment settled after the Nisqually Earthquake in February 2001. See Photo 16. All concrete approach foundations were rehabilitated in the early 1970s, including replacement of the top portion of the timber piling.

Settlement at abutment due to the Nisqually Earthquake in February 2001.

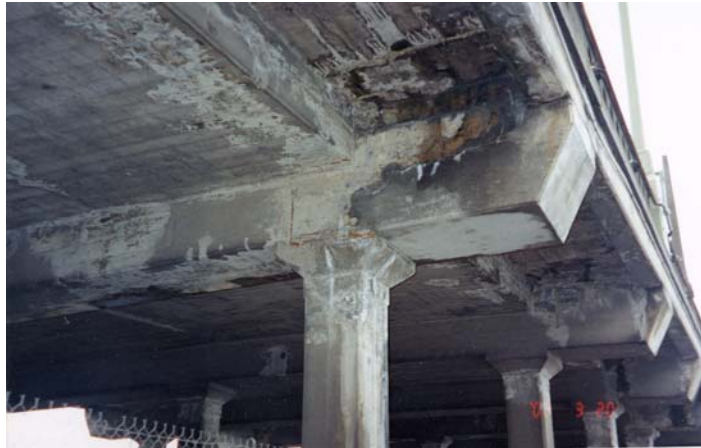
Photo 17: Concrete Approach Piers

It is highly probable that the large deep cracks appearing along the pier caps and the numerous cracks perpendicular to the primary cracks are caused by expansive stresses due to the alkali-silica reaction [Ref. 6]. See Photo 17. Cracks are especially apparent at every third bent, where defective expansion joints in the roadway have allowed water onto the cap beam.

Note large cracks appear along pier caps.

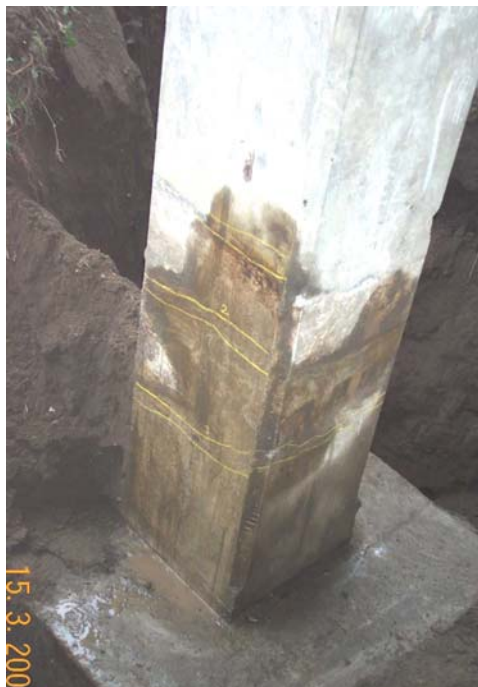
Photo 18: Concrete Approach Column

After the Nisqually Earthquake in February 2001, inspections found that multiple columns cracked in both the south and north approaches. The cracks appeared near the tops of columns, at bases, and a few feet below the ground. Inspections also found settlement of the span between the south abutment and Pier 2, and rail, rail beam and cap damage due to collision with the adjacent steel truss structure at Pier 13 [Ref. 41]. See Photos 18, 19 and 20.

Note multiple cracks in column.

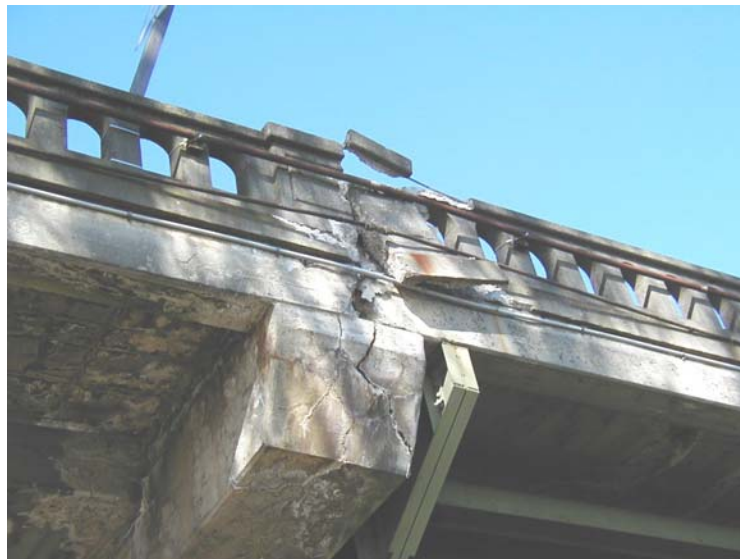
Photo 19: Concrete Rail and Slab Nisqually Earthquake Damage

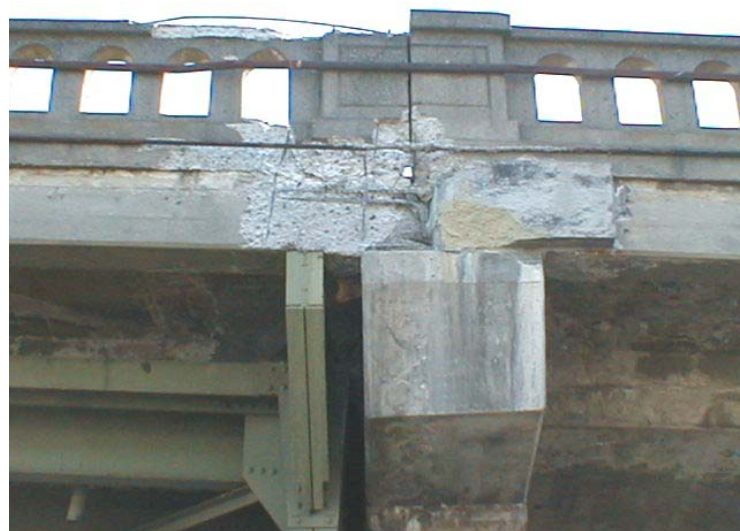
Photo 20: Concrete Rail and Slab Nisqually Earthquake Damage Detail

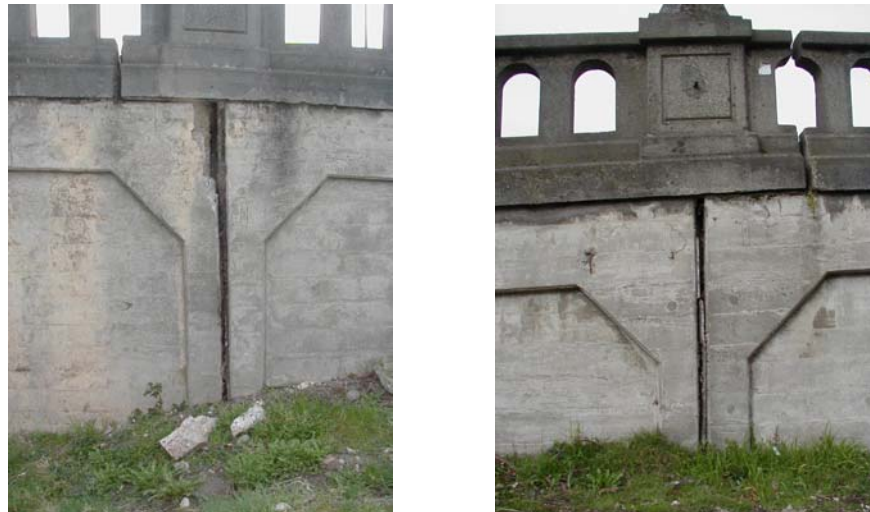
Photo 21: Retaining Wall Nisqually Earthquake Damage

All these retaining walls are supported on spread footings. Widening of retaining wall joints caused by settlement and spreading of walls, was found after the Nisqually Earthquake in February 2001 [Ref. 41]. See Photo 21.

Note settlement damage to retaining wall, resulting in widening of vertical joints.

Retaining walls along the south approach were rotated and cracked during the Nisqually Earthquake. Tieback or soil nailing with a cast-in-place reinforced concrete face in front of the existing wall are recommended to restore the wall. See Figure 16.

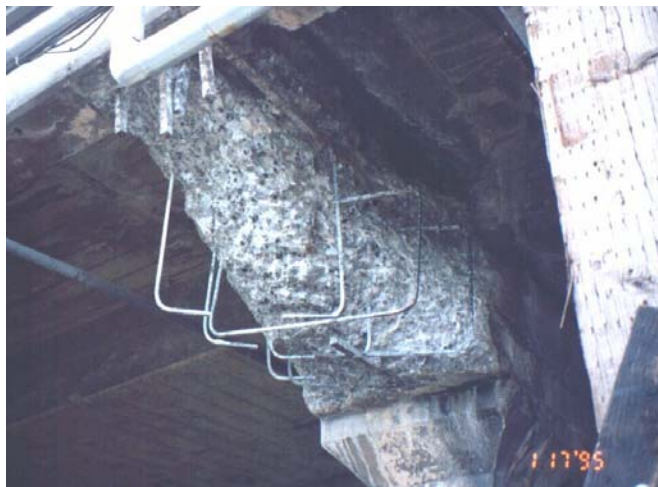
The concrete of the piers and abutments is spalling and cracked [Refs. 6, 7, 19, 41]. In 1995, repairs were made to multiple pier caps. As is typical with spall repairs, the crews attempted to chip away the bad concrete on the cap until sound concrete is reached. Chipping away at spalls and cracks revealed that the interior concrete is also in poor condition. On the west end of bent 4 on the north approach, concrete was so deteriorated that progress on the cap had to be stopped because the chipping was approaching the first column. This would have resulted in chipping away the entire cantilevered portion of the cap (see Photo 25). This investigation determined the deterioration was not due to corroding around the concrete rebar, but rather to uniformly poor material throughout the concrete section. For each cap repair, a new cage of No. 5 bar was doweled in before pouring new concrete. Every third bent is especially bad, because the expansion joints have leaked water onto these caps for years. The condition of the caps at bents 4, 7, 10, and 13 (abutment = bent 1) were worse than the other non-expansion joint caps (see Photo 26). In the late 1990s, all of these caps were repaired under expansion joints on both approaches. Further review of as-built drawings also show that pier reinforcement is sparse and inadequate for providing the confinement and detailing necessary to resist seismic loads. A previous study found that “the system...may fail in a major earthquake” [Ref. 5].

Photo 25: Unsound Concrete Removed During Repair of Bent 4 of the North Approach

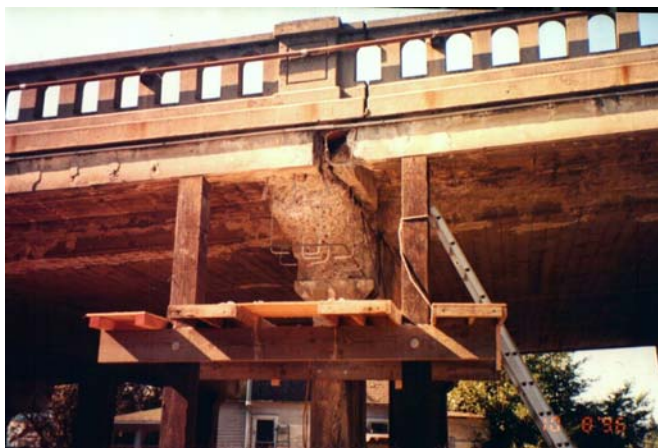
Photo 26: Unsound Concrete Removed During Repair of Bent 7 of the South Approach
